1994 Northridge Earthquake

Performance of Structures, Lifelines and Fire Protection Systems

NISTIR 5396

March 1994
Building and Fire Research Laboratory
National Institute of Standards and Technology
Gaithersburg, MD 20899

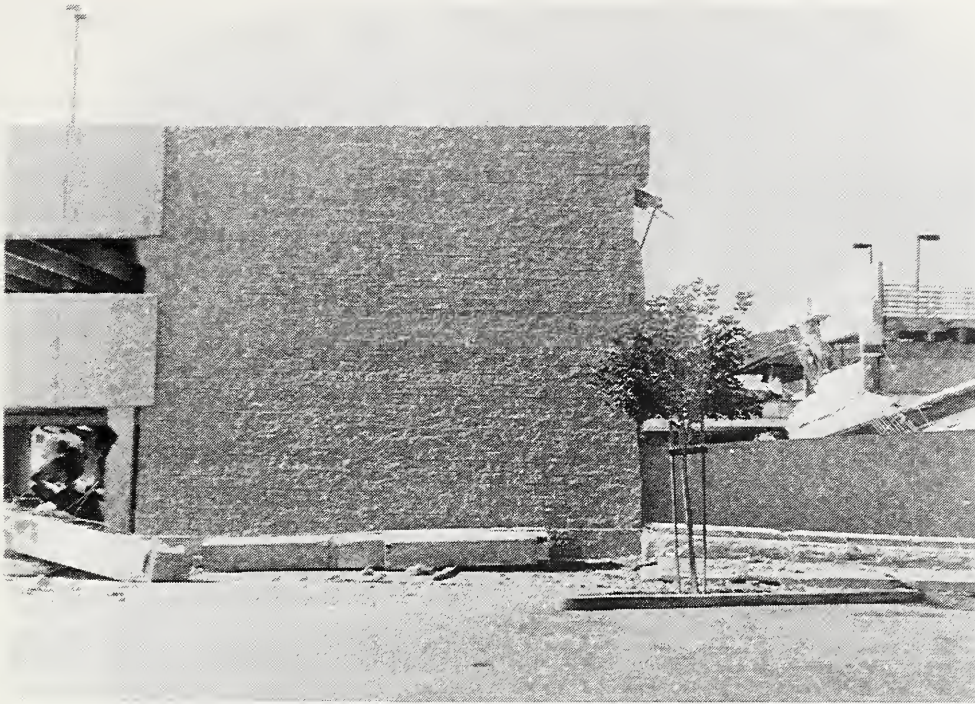
At the Northridge Fashion Center, three parking structures suffered damage. A large three-level concrete garage at the south end of the site, approximately ten years old, suffered an almost complete collapse. The largely pre-cast concrete structure had intermittent shear walls which remained standing (Figure 3.66). The lack of diagonal cracks in these walls suggests that, like the walls at the Kaiser Permanente garage, they were never fully loaded. A similar, but smaller, precast garage at the north end of the Northridge Fashion Center also partially collapsed (Figure 3.68). At the east end of the site, an older two-level cast-in-place concrete garage showed

Figure 3.66 At the Northridge Fashion Center, major portions of the three-level south parking garage collapsed. The garage was precast concrete with intermittent shear walls. Most of the shear walls remained standing, largely undamaged, indicating that the lateral load was not adequately transmitted to these walls.

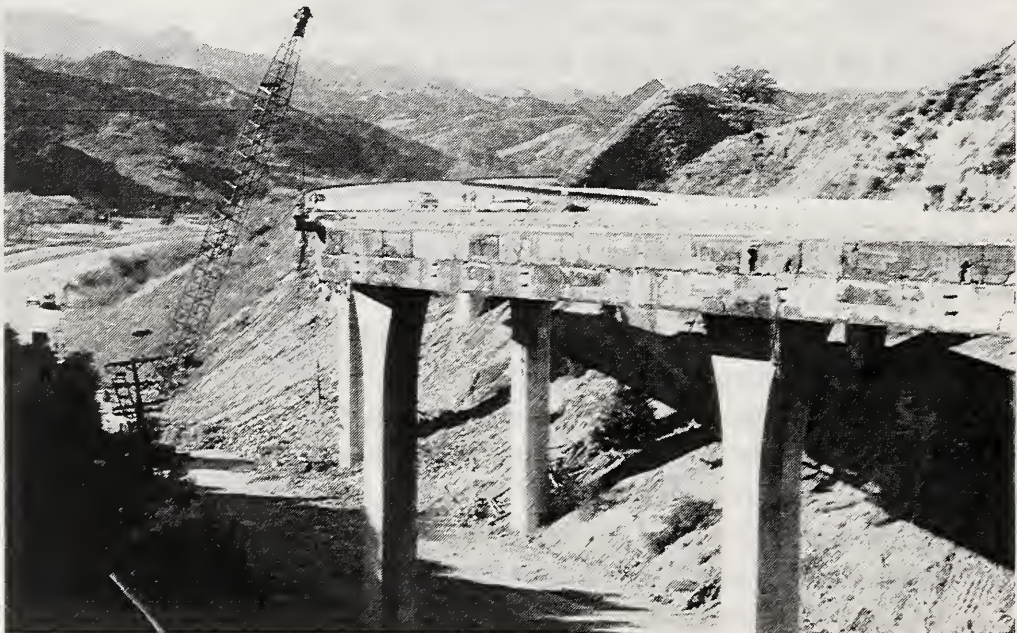
Despite the presence of cable restrainers at the hinges, failure of three of the four end spans of the bridge was apparently initiated by the spans falling off the hinge seats. The fourth end span, at the far western corner of the bridge, partially came off its hinge seat but did not collapse, as indicated in Figure 4.4. After support was lost at the hinges, a triangular portion of three of the end spans collapsed, as shown in Figure 4.4. Demolition of the remaining portions of the end spans was carried out very soon after the earthquake, as shown in Figure 4.2. It is likely that the skewed alignment of the bridge was an important contributing factor in this failure. The skewed alignment permitted rotation of the superstructure in a counter-clockwise direction, when viewed from above. The tall, flexible piers of the two center bents would have offered relatively little resistance to rotation in a horizontal plane. (EERC reconnaissance team members noted cracking patterns at the bases of the piers, which may have been evidence of such rotation [EERC, 1994, p. 5-4]). Rotation of the superstructure would have resulted in differential displacements at the hinges, and eventually unseating of the end spans at the hinges. Demolition of the bridge was completed a few days after the earthquake.

Figure 4.3 Ground level view of the southbound bridge at Gavin Canyon, looking to the northwest, showing the hinge bearing seat near Bent 3.

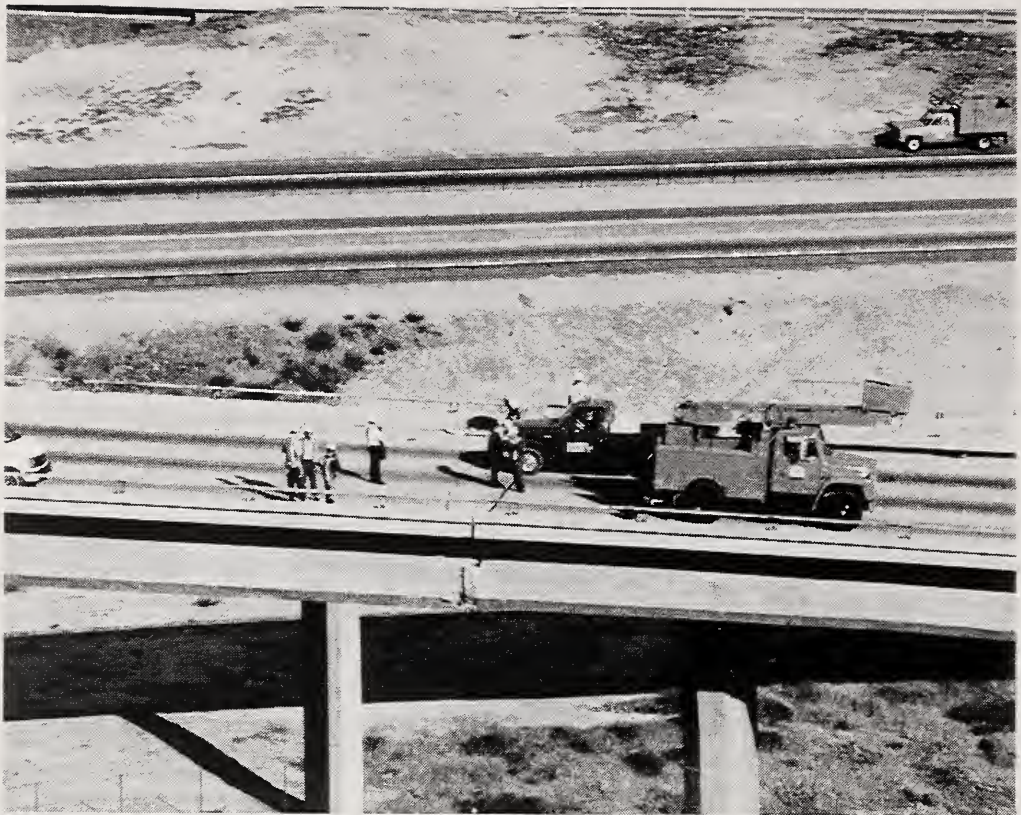
Figure 4.7 Example of pounding and offset at a hinge in the SR14/I5 interchange

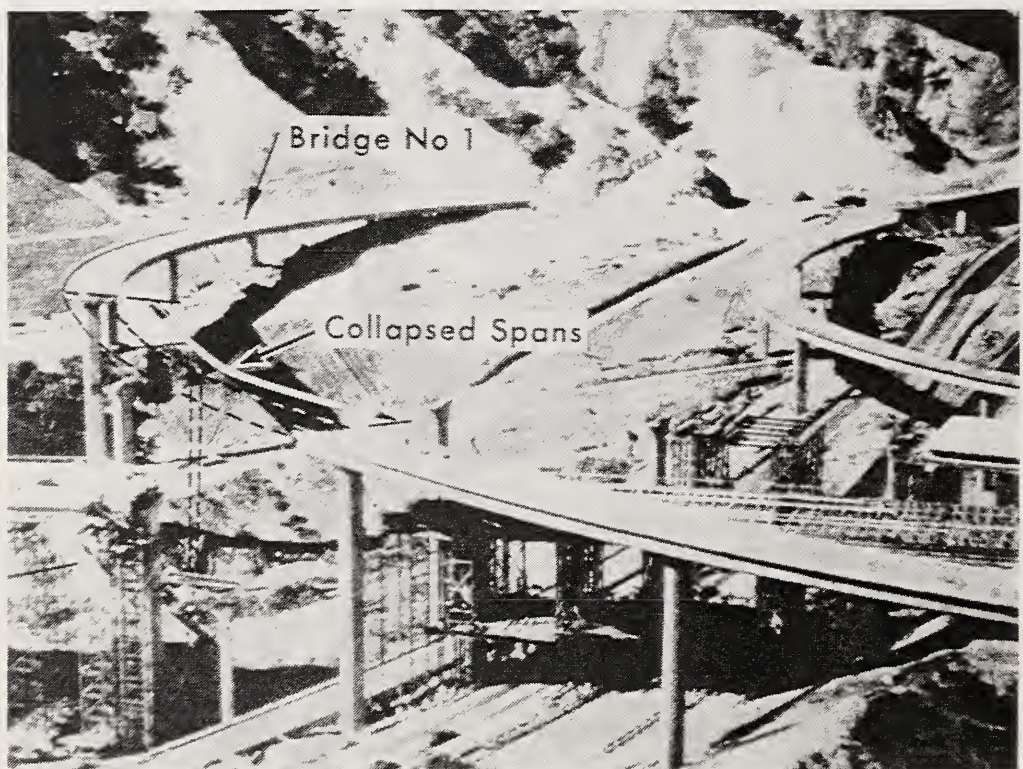
This interchange was designed in 1968 and was under construction in 1971 when portions were damaged by the San Fernando earthquake. At that time, one of the completed ramps in the interchange collapsed, and two ramps which were under construction were damaged. The portion which collapsed in 1971 was the South Connector Overcrossing, connecting southbound I5 with eastbound SR14. A photograph of the collapsed ramp, taken in 1971, is shown in Figure 4.8. This ramp was later rebuilt, with improved pier reinforcement, and it suffered no significant damage in the Northridge earthquake. The damaged portions of the other two ramps under construction in 1971 were repaired in place, but not strengthened; the portions not yet constructed were completed with limited seismic upgrading. Both of the ramps which partially collapsed in the Northridge earthquake were under construction at the time of the 1971 earthquake.

Figure 4.8 SR14/I5 interchange after the 1971 San Fernando earthquake. View looking to the west, showing collapsed South Connector Overcrossing

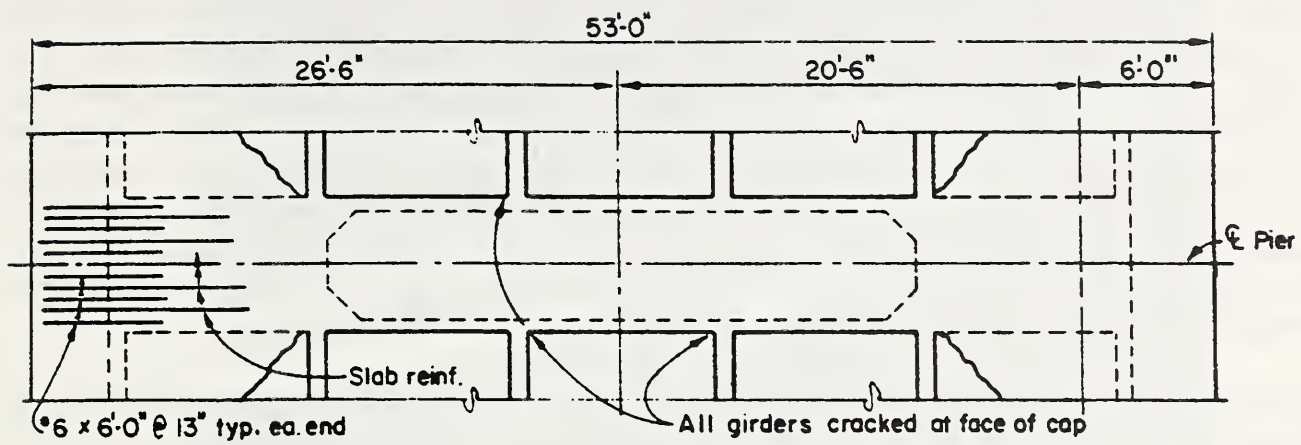
Figure 4.13 Cracking reported at Piers 2 and 3 following the 1971 San Fernando earthquake (Reproduced from State of California, 1971)

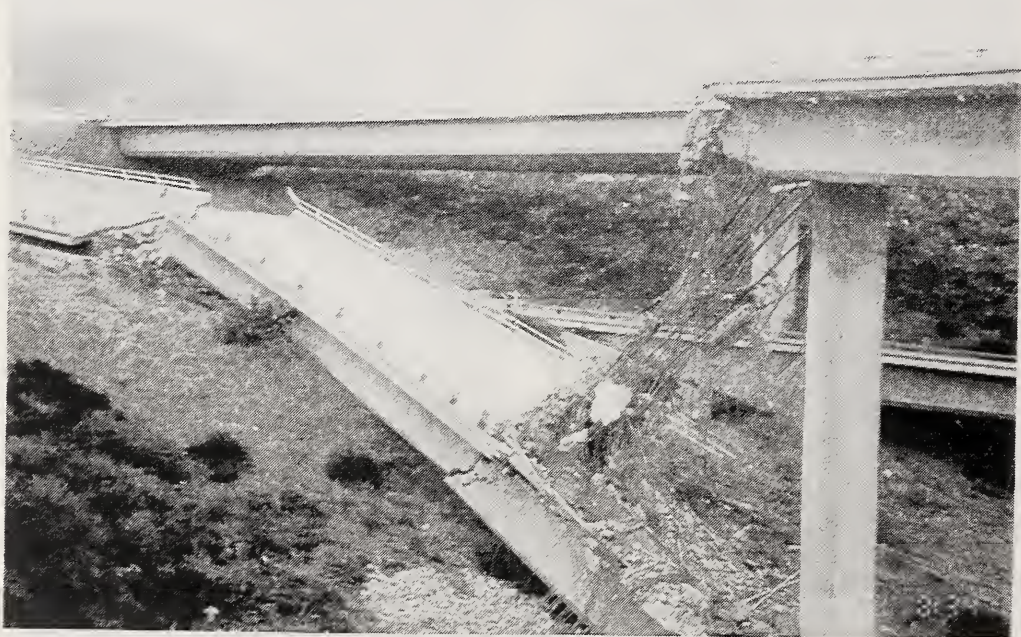
The collapse in the Northridge earthquake appears to have been initiated by the failure of Pier 2. After Pier 2 failed, the simply supported span between Abutment 1 and the hinge near Pier 2 collapsed, and, as shown in Figure 4.15, the superstructure failed in bending near Pier 3 due to a large negative moment. Pier 2 completely disintegrated, as shown in Figure 4.16. This is the shortest pier in the structure, so it is likely that it attracted a high level of lateral force, was damaged in shear, and finally collapsed in compression. Pier 10 is similar in height to Pier 1, but the quantities of lateral reinforcement in Pier 10 are greater than those in Pier 1, as illustrated in Figure 4.18. This is because Pier 2 had already been completed, but Pier 10 had not yet been constructed, when the 1971 earthquake occurred. Following the 1971 earthquake the plans for Pier 10 were revised to provide increased lateral reinforcement, as shown in Figure 4.18.

Figure 4.14 Collapsed portion of the SR14/I5 North Connector Overcrossing, looking east.. Pier 2 was at the left, near the broken hinge on the ground (Courtesy of EERC)

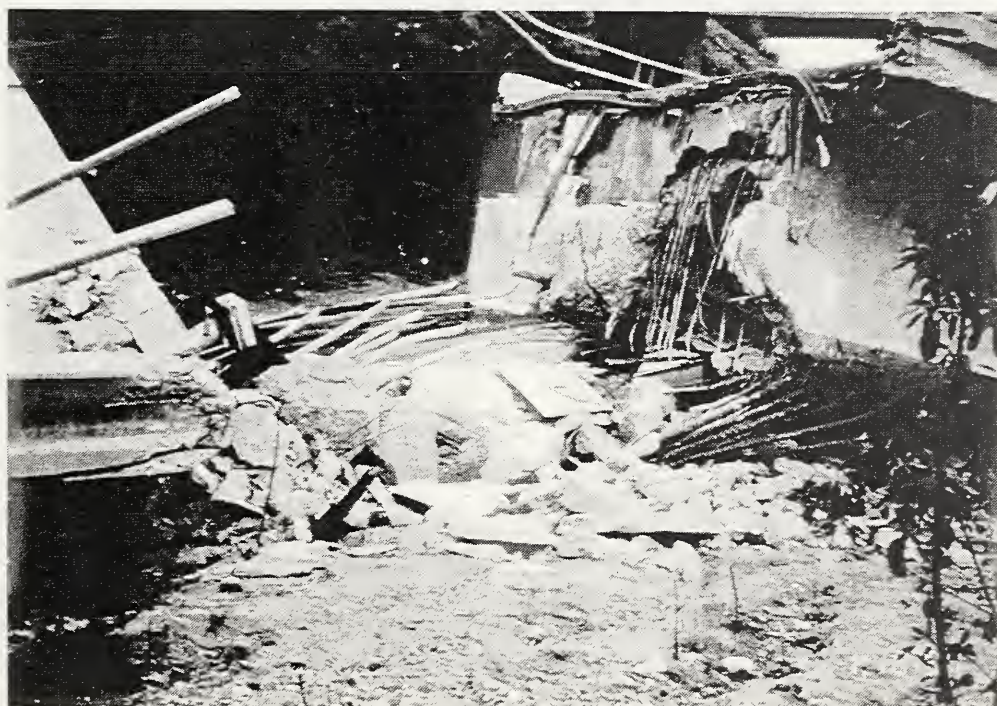
Figure 4.16 View of crushed Pier 2 and the hinge near Pier 2 (Courtesy EERC)

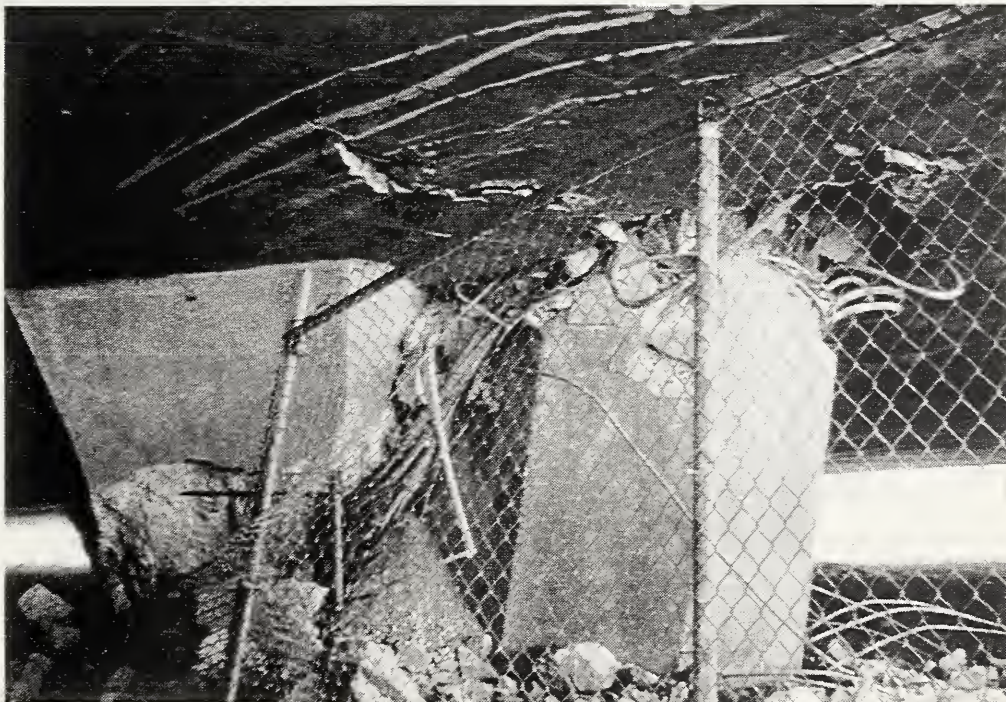
Figure 4.22: Damage to a pier of the SR118 Mission-gothic Undercrossing, looking to the west at Bent 4 of the eastbound bridge, which collapsed (Courtesy of EERC)

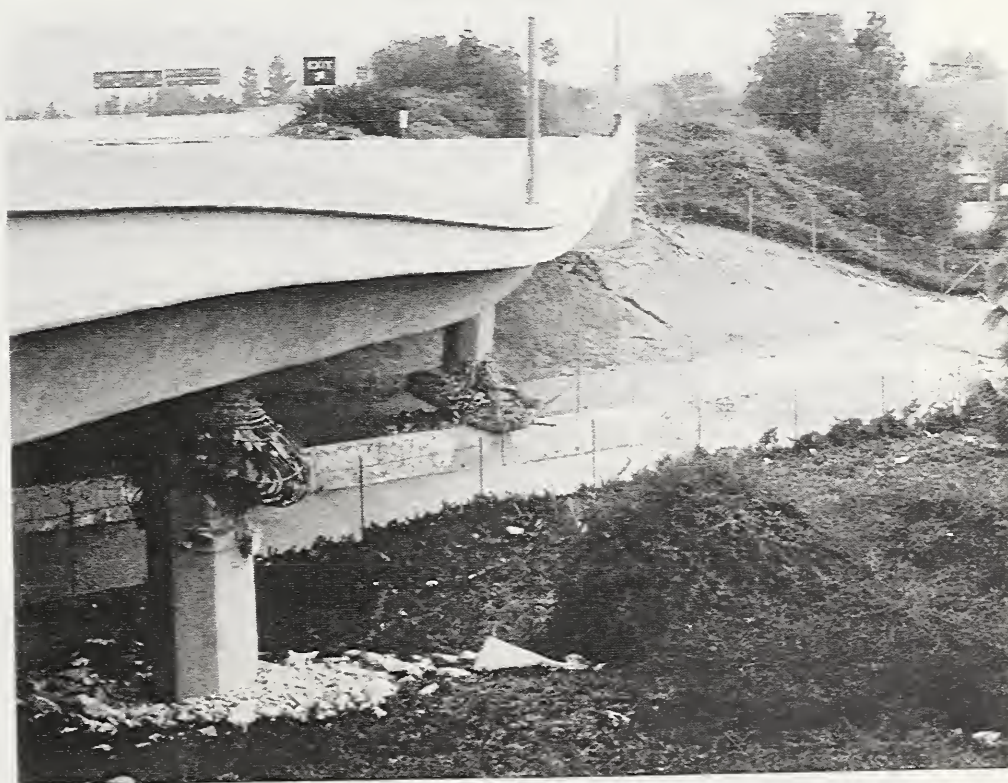
All ten of the piers in Bent 3 failed in combined shear and compression near their bases, as shown by Figures 4.27 and 4.28. In Bent 2, Piers on the south side of the span failed near their top end, as shown in the left foreground of Figure 4.26, and the damage became progressively less for piers to the north in Bent 2. The farthest north piers in Bent 2 showed relatively little damage - only diagonal shear cracks near the base, with no spalled concrete. This uneven distribution of damage to piers was probably caused by the asymmetric plan geometry of the bridge, as shown in Figure 4.29.

Figure 4.26 Ground-level view of State Route 118 at Bull Creek Canyon Channel, looking along the south edge, towards the east

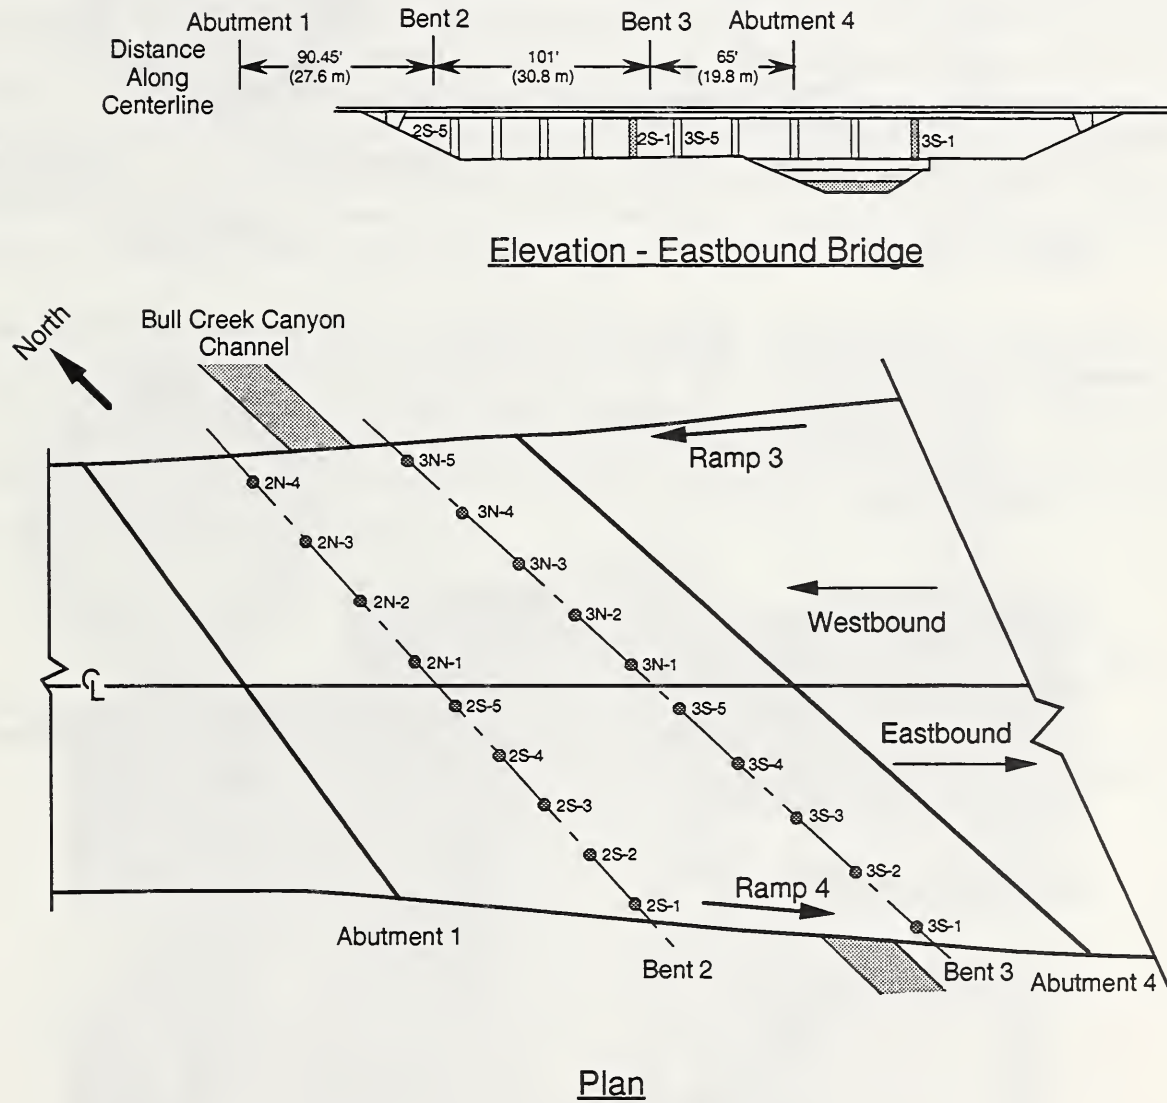
Figure 4.29 Plan and elevation views of State Route 118 at Bull Creek Canyon Channel

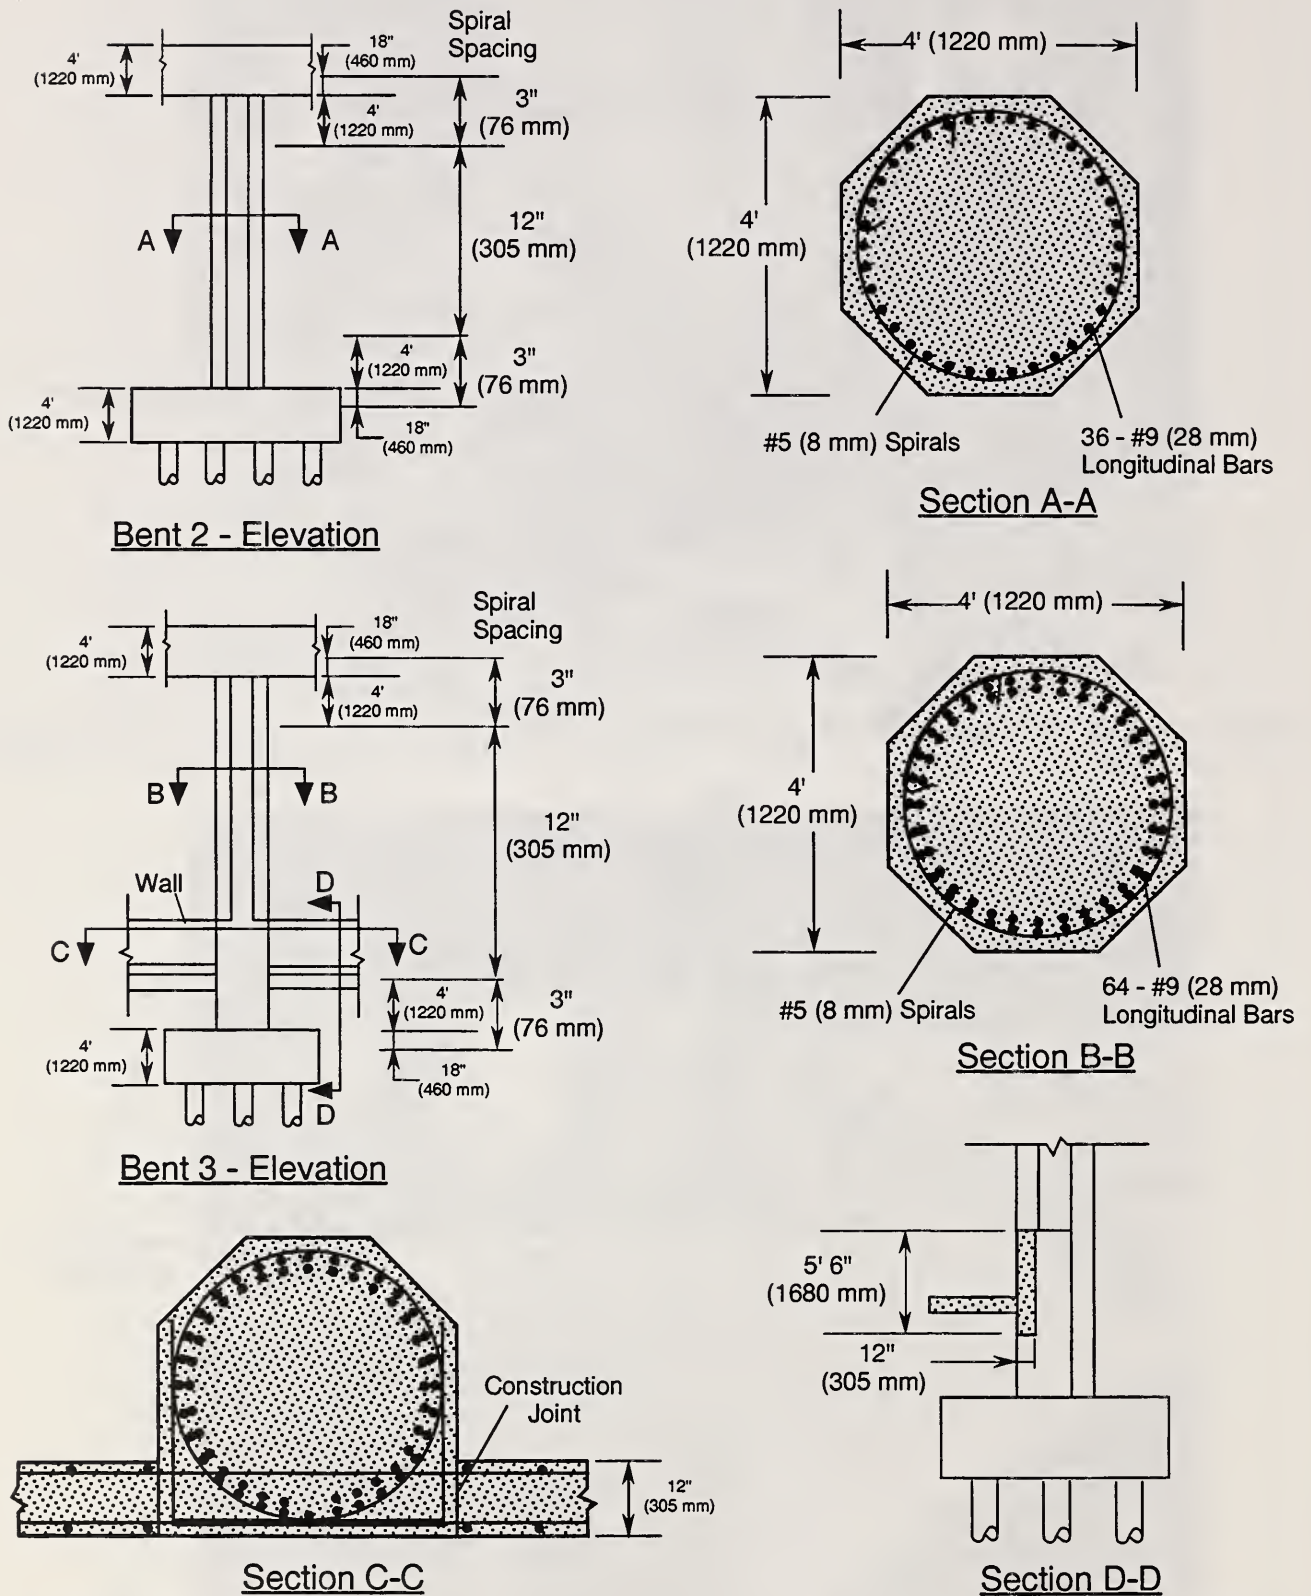
The confining reinforcement in the piers, shown in Figure 4.30, is inadequate by current standards. Spiral confining hoops were spaced at 76 mm (3 in.) near the top and bottom of each pier (presumably to provide confinement in potential plastic hinge regions), but the spacing was 305 mm (12 in.) over most of the pier height. All pier failures occurred in the zone of wide spiral spacing. Another factor contributing to pier failure was that the effective lengths of the piers were much shorter than the distance between the footings and the girder soffit. The lengths of piers varied between roughly 6000 and 9100 mm (20 and 30 ft.). In Bent 2, the effective pier lengths were decreased roughly one-third by compacted backfill soil above the pier footings. In Bent 3, the pier lengths were also decreased roughly one-third, but by a reinforced concrete channel liner wall, which was cast abutting the piers (Figure 4.30, Section C-C). The shortened effective pier length resulted in stiffer piers, which were more susceptible to shear-dominated failure than bending-dominated failure.

Figure 4.30 Pier details for State Route 118 at Bull Creek Canyon Channel

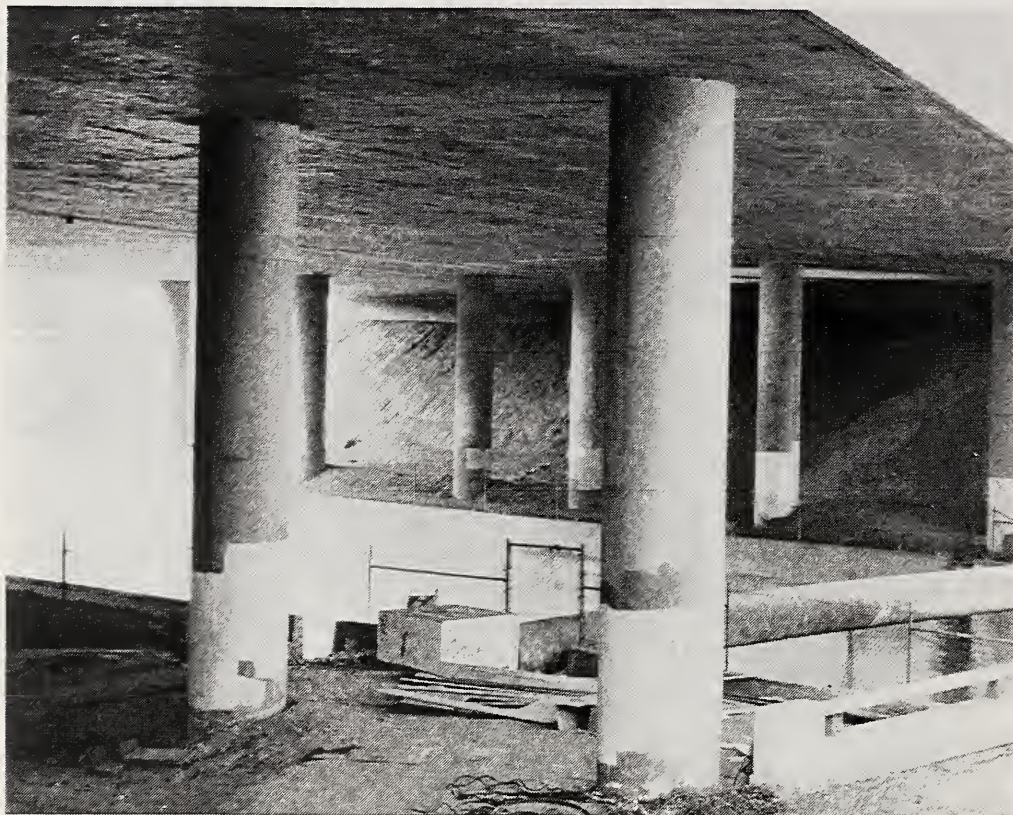
Between the two bridges which collapsed, I10 passes over Ballona Creek. Figure 4.33 is a view looking toward the southwest of the spans over the creek. There was essentially no damage to the supporting piers. Adjacent to the bridge over Ballona Creek, there is a westbound ramp which exits from I10 to Cadillac Ave. A portion of this ramp is supported by single piers which have been retrofitted with steel jackets, as shown in Figure 4.34. No damage was noted to these retrofitted piers. The Cadillac Ave. ramp represents the only case known to the authors where undamaged retrofitted piers were located close to major collapse sites. However, because the retrofitted Cadillac Ave. ramp piers were immediately adjacent to an older, non-retrofitted multispan bridge which was undamaged (the Ballona Creek overpass), it is not known whether the Cadillac Ave. ramp piers were subjected to the same levels of lateral forces as piers at the two collapse sites at La Cienega-Venice and Fairfax-Washington.

Figure 4.33 I10 Bridge over Ballona Creek, looking to the southwest

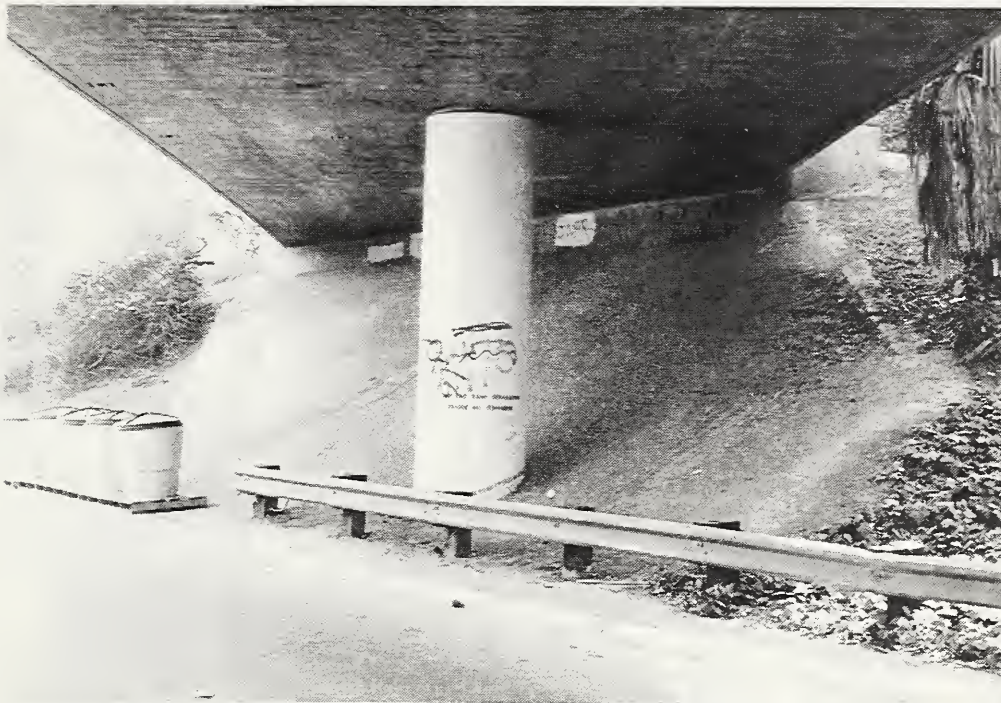
Figure 4.34 Cadillac Ave. ramp; view to east showing jacketed pier

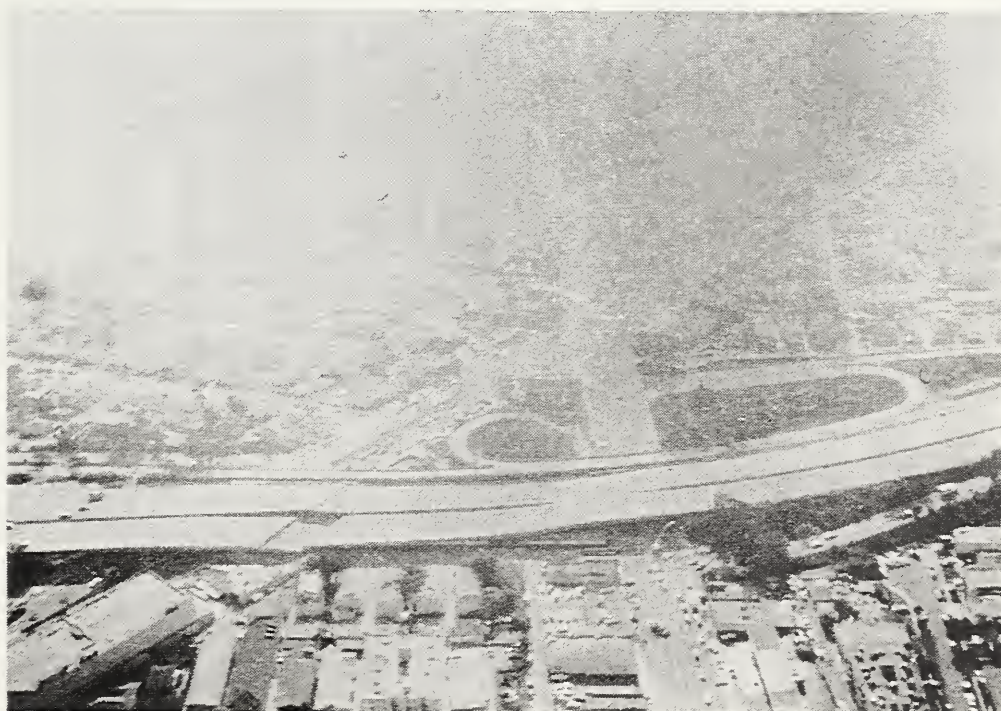
Figure 4.35 is an aerial view of I10 where it passes over La Cienega Blvd. and Venice Blvd. The view is toward the south, and Venice Blvd. is the diagonal street on the left side of the photograph. The portion of the westbound lane which collapsed to ground level can be seen. However, there was extensive damage to most of the supporting piers of the eastbound and westbound lanes.

Figure 4.35 Aerial view (looking south) of I10 Separation at La Cienega Blvd. and Venice Blvd., (Courtesy of FHWA)

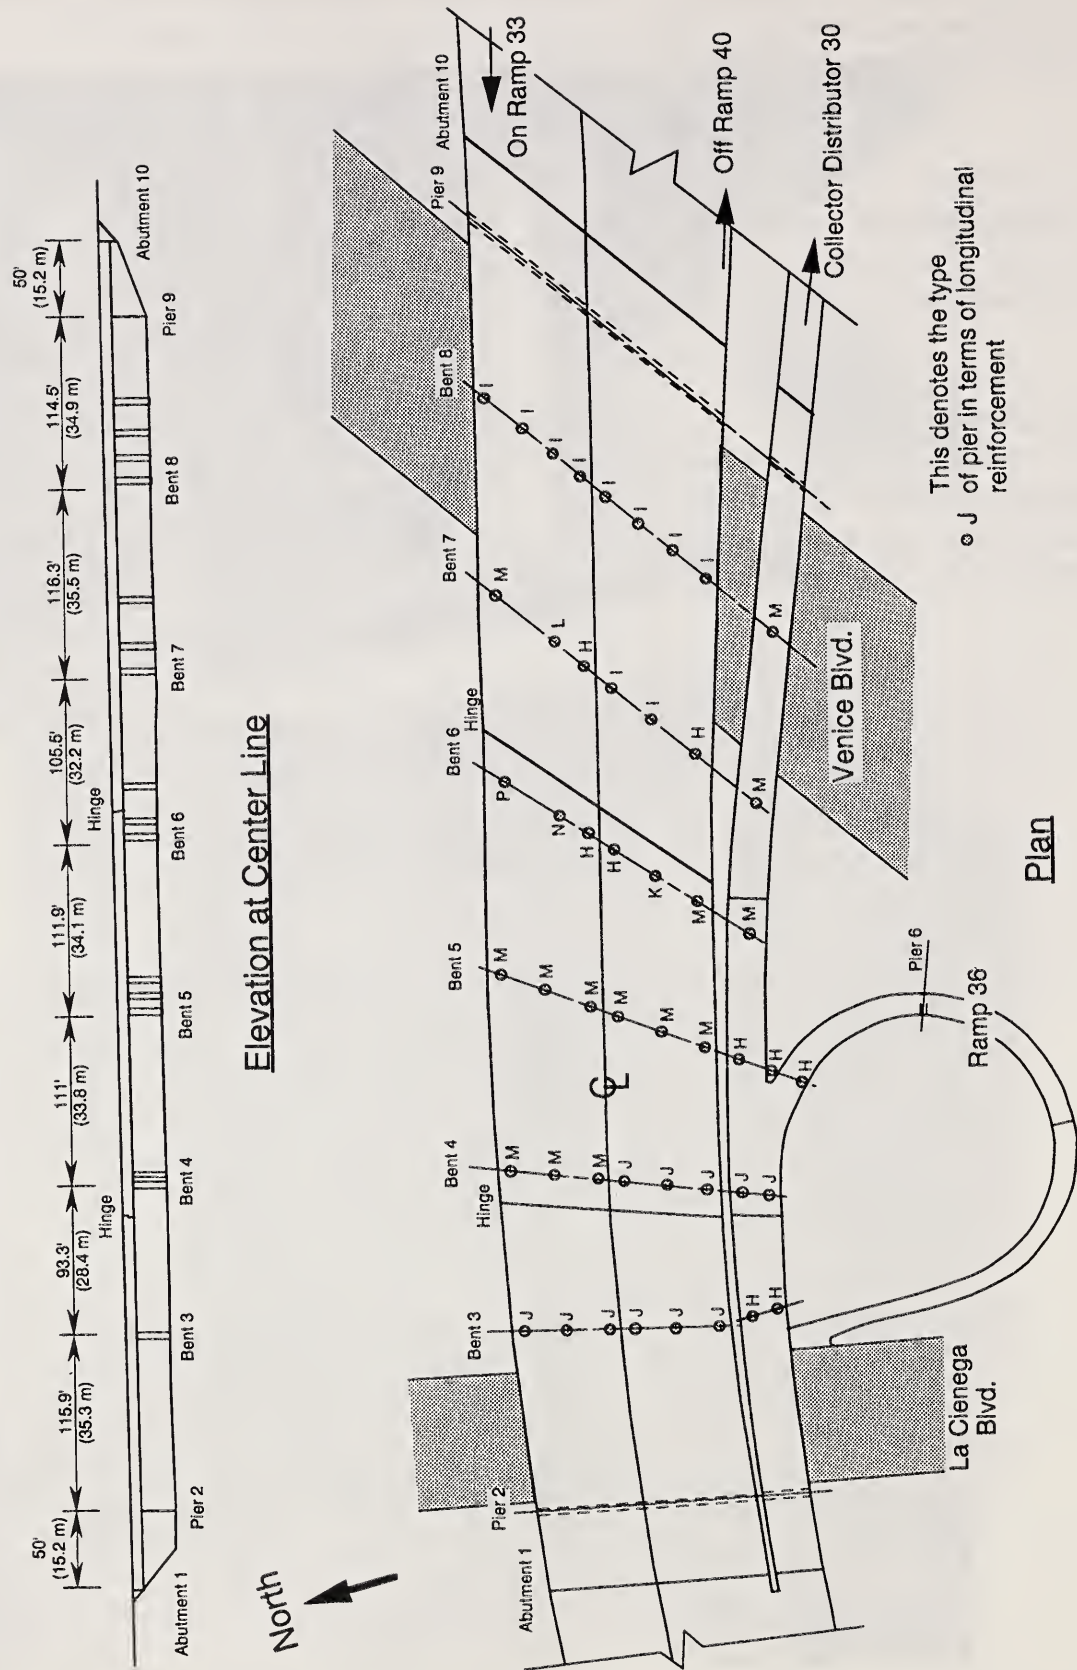
Figure 4.36 shows elevation and plan views of the nine-span bridge structure. Solid wall piers provided support adjacent to the abutments, and the remainder of the supports were multiple-pier bents. Two expansion joints (hinges) were provided as shown. Bents 3 to 7 included three supporting piers for each lane, while Bent 8 had four piers per lane. The exit ramp to La Cienega Blvd. and the eastbound collector-distributor did not collapse. Figure 4.37 shows the pier details. The piers had circular cross sections with a diameter of 1220 mm (4 ft.), and the longitudinal reinforcement consisted of #11 (35 mm) or #18 (57 mm) deformed bars. The different pier reinforcement configurations were identified by pier "types" as shown in Figure 4.37. These pier types are indicated in the plan shown in Figure 4.36. The lateral reinforcement consisted of #4 bars (13 mm) at 305 mm (12 in.) vertical spacing.

Figure 4.36 Elevation and plan of I10 Separation at La Cienega Blvd. and Venice Blvd.

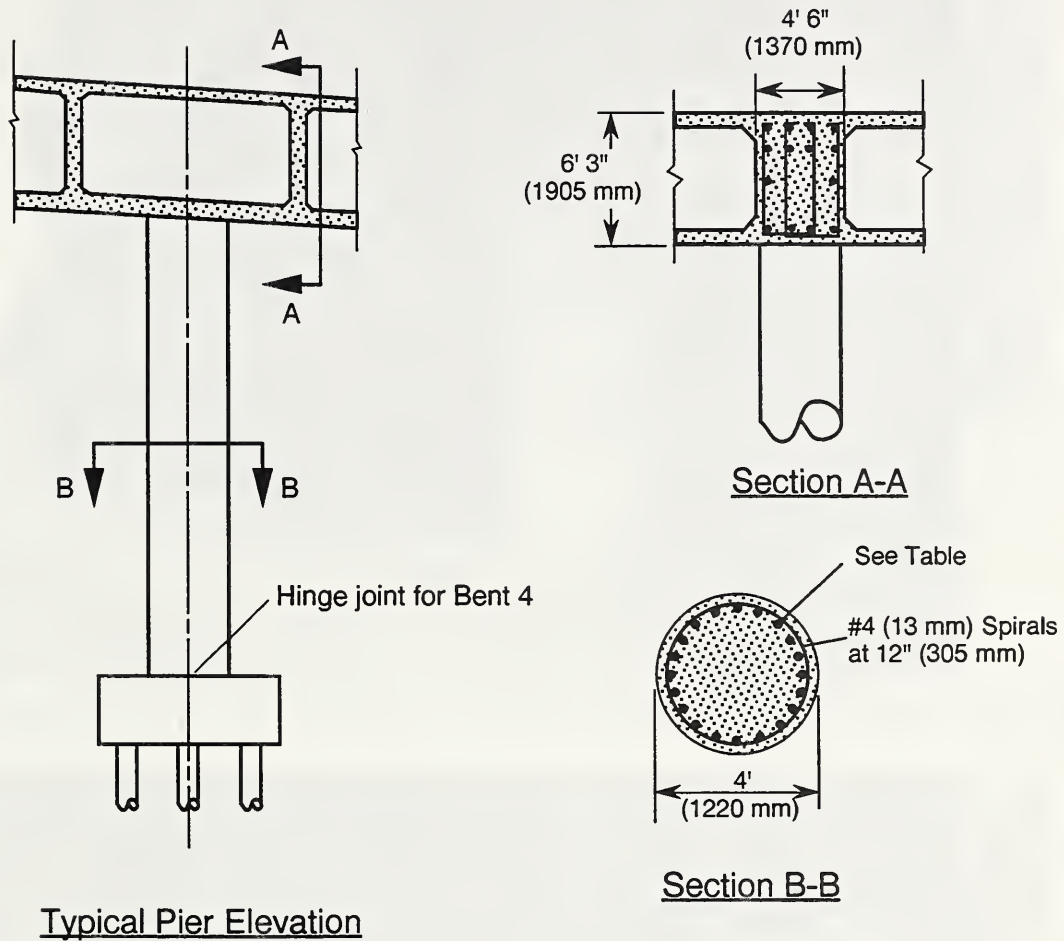
Figure 4.37 Pier details for I10 Separation at La Cienega Blvd. and Venice Blvd.

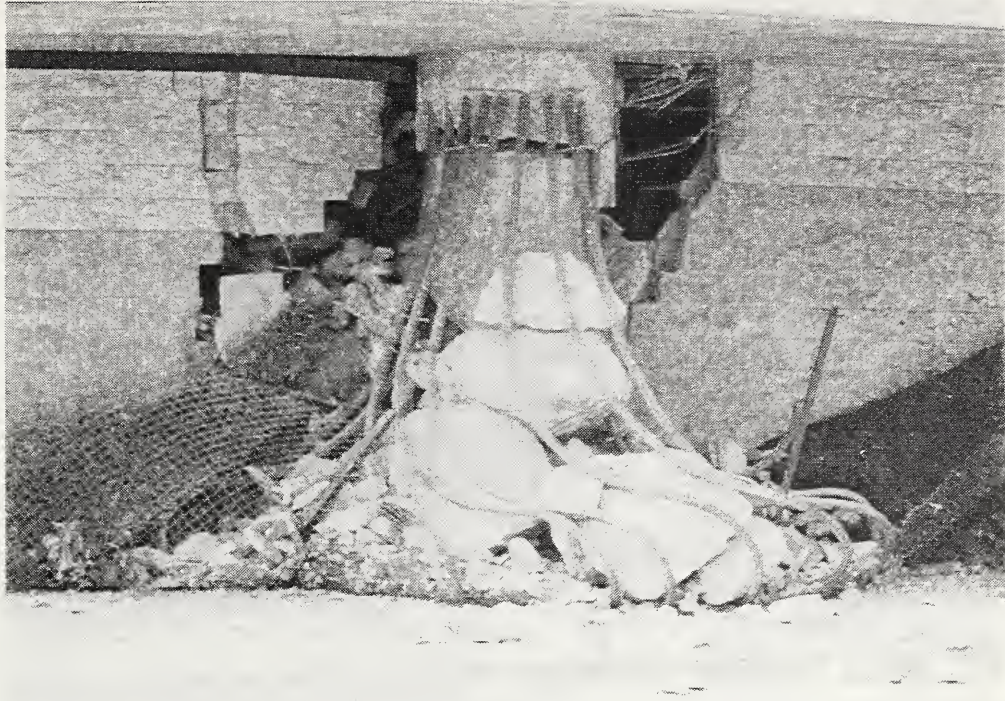
Figure 4.40 shows the northernmost pier of Bent 6, located just to the west of the hinge. This pier totally disintegrated, but the storage building prevented the roadway from collapsing to the ground. Figure 4.41 shows the southernmost pier supporting the eastbound lane at Bent 3. The top of the pier is severely damaged and it is likely that the storage building prevented the total collapse of the roadway.

Figure 4.40 Northernmost pier of Bent 6 supporting westbound lane of I10 (west of Venice Blvd.)

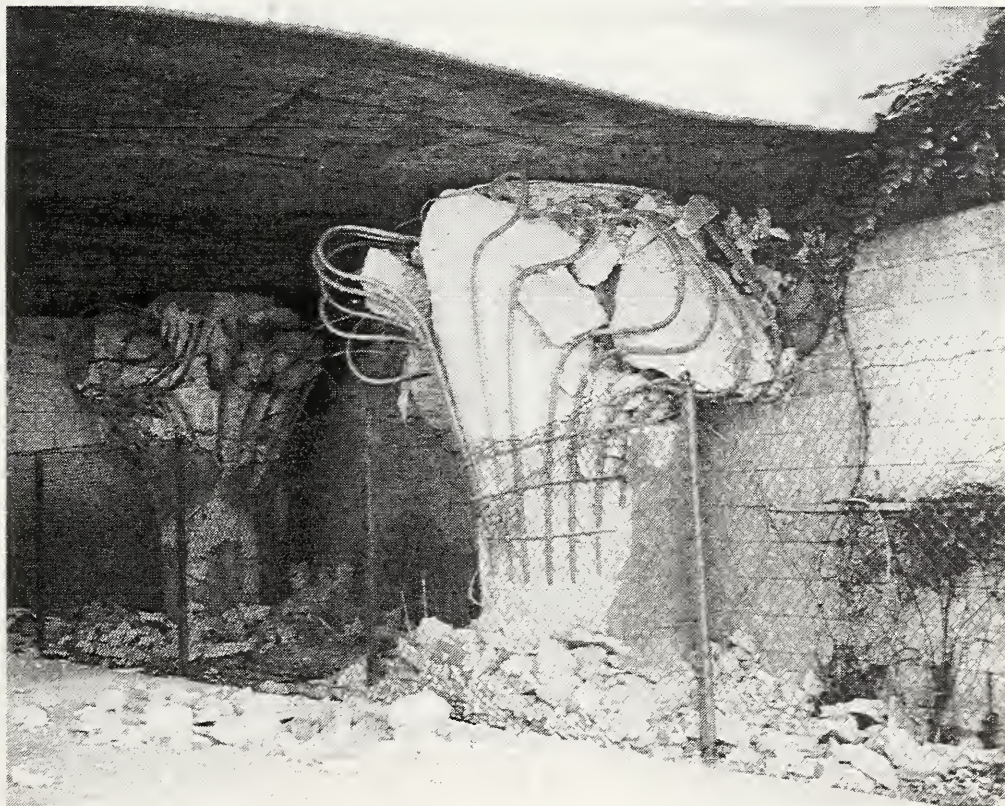
Figure 4.41 Piers of Bent 3 supporting eastbound lane of I10 at La Cienega Blvd.

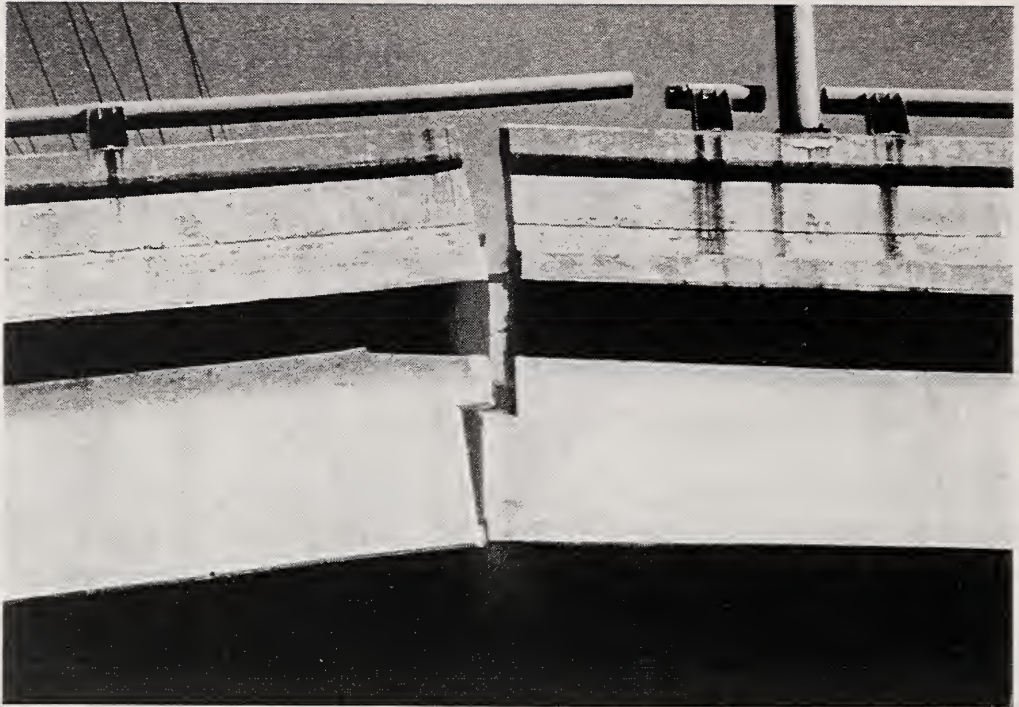
Figure 4.43 Hinge adjacent to Bent 4 of I 10 at Fairfax Ave.; cable restrainers prevented loss of support (Courtesy of EERC)

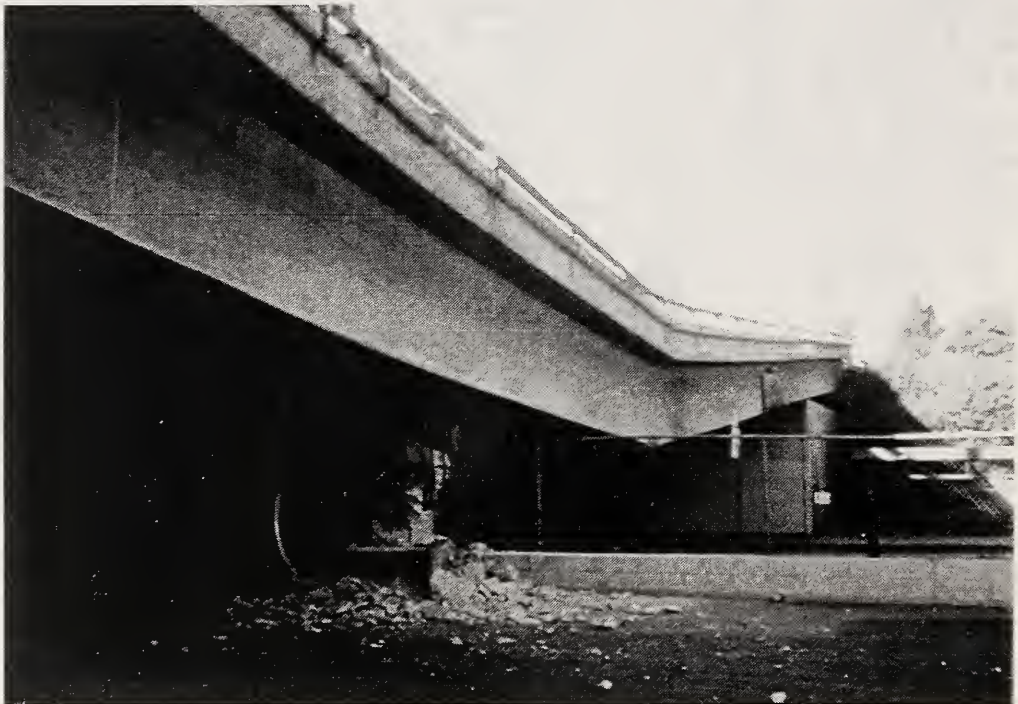
Figure 4.44 View of collapsed span of I10 over Fairfax Ave.; note rotation of girder over Pier 2 (Courtesy of EERC)

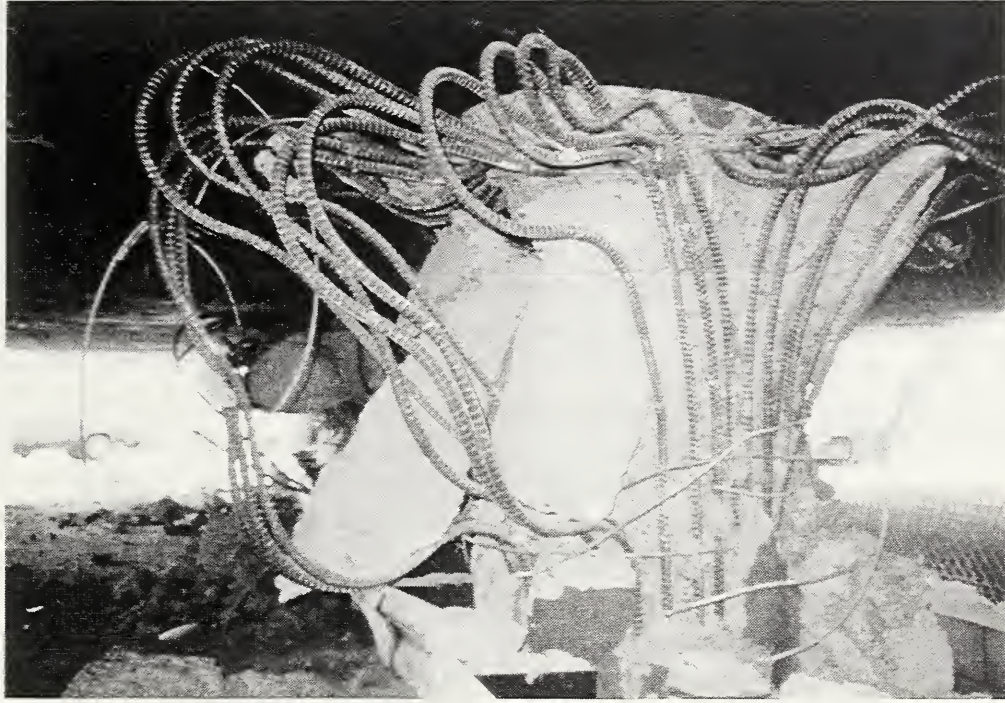
Figure 4.45 Failed column in Bent 3 of I10 at Fairfax Ave. (Courtesy of EERC)
